# SEASPAN VANCOUVER DRYDOCK WATER LOT EXPANSION HABITAT ASSESSMENT

**Seaspan ULC**

# SEASPAN VANCOUVER DRYDOCK WATER LOT PROJECT HABITAT ASSESSMENT

**JUNE 2021**

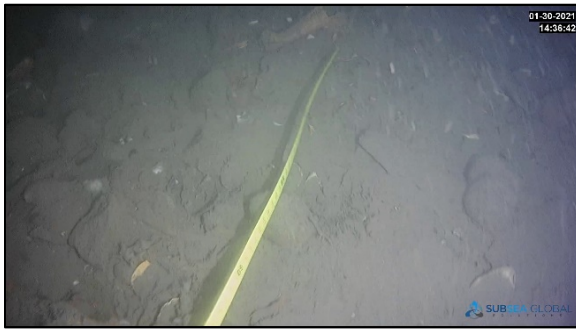
**Cobble and silt:** Cobbles were present in some of the Study Area and were always covered in silt. Photo from T1, under careen.

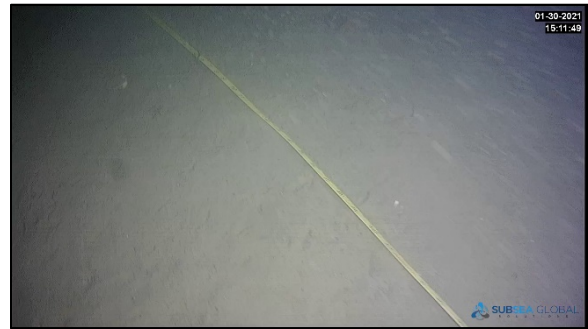
**Silt:** Silt was the dominant substrate in the Study Area. Photo from T3.

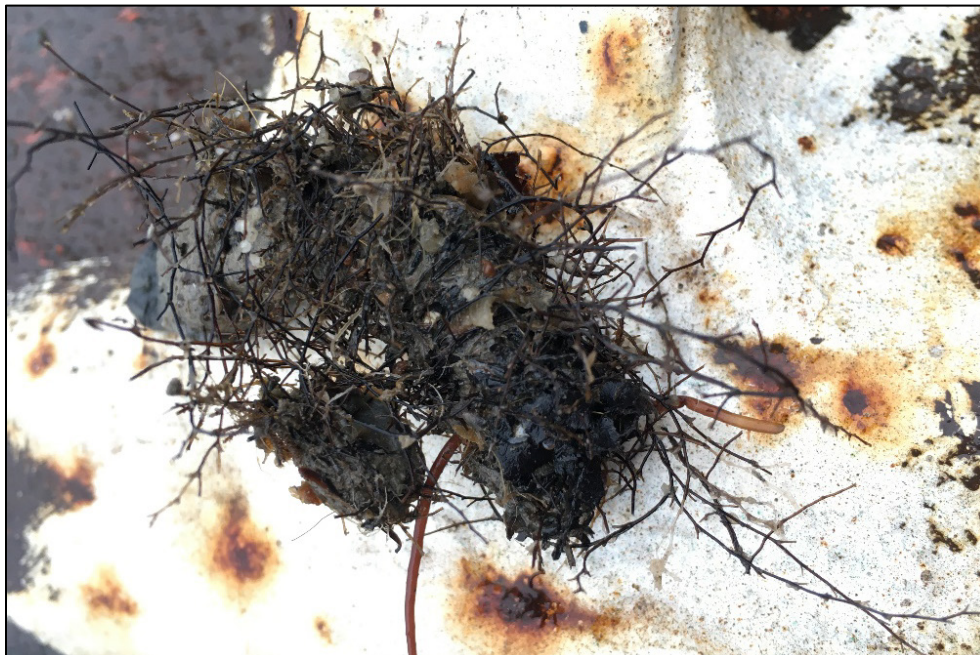
**Figure 7**      **Unknown algae and detritus attached to an empty worm tube.**

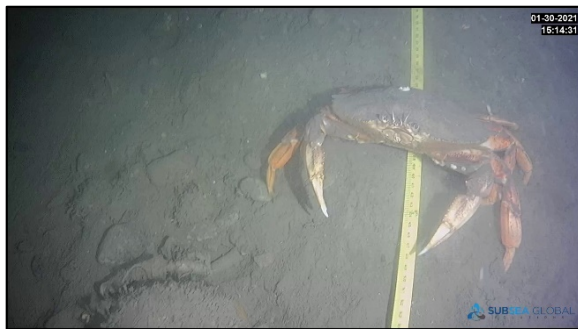
Dungeness crabs were observed throughout the Study Area.

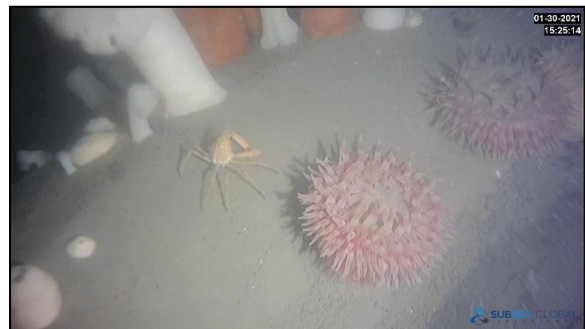
Longhorn decorator crab, painted anemones (pink) and giant plumose anemones (orange and white) on a large tire.

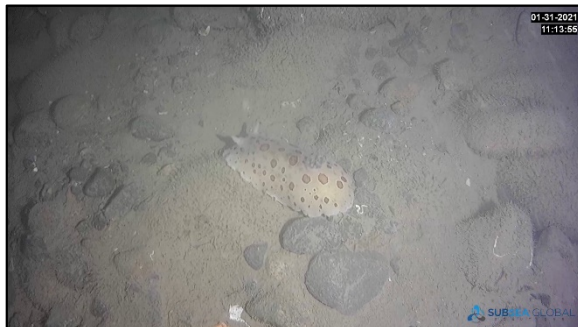
Spotted leopard doris nudibranch on cobbles and silt.

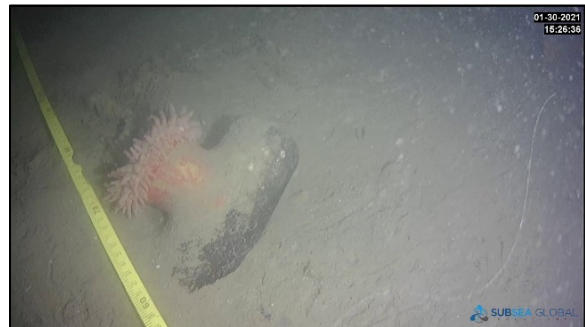
Painted anemone on a glass bottle.
